**PHASE II ENVIRONMENTAL SITE ASSESSMENT
REPORT**

**1.48-Acre Safeway/American Legion Property
1153 Duane Street and 1132 Exchange Street
Astoria, Oregon**

April 14, 2003

HAI Project No. 6081

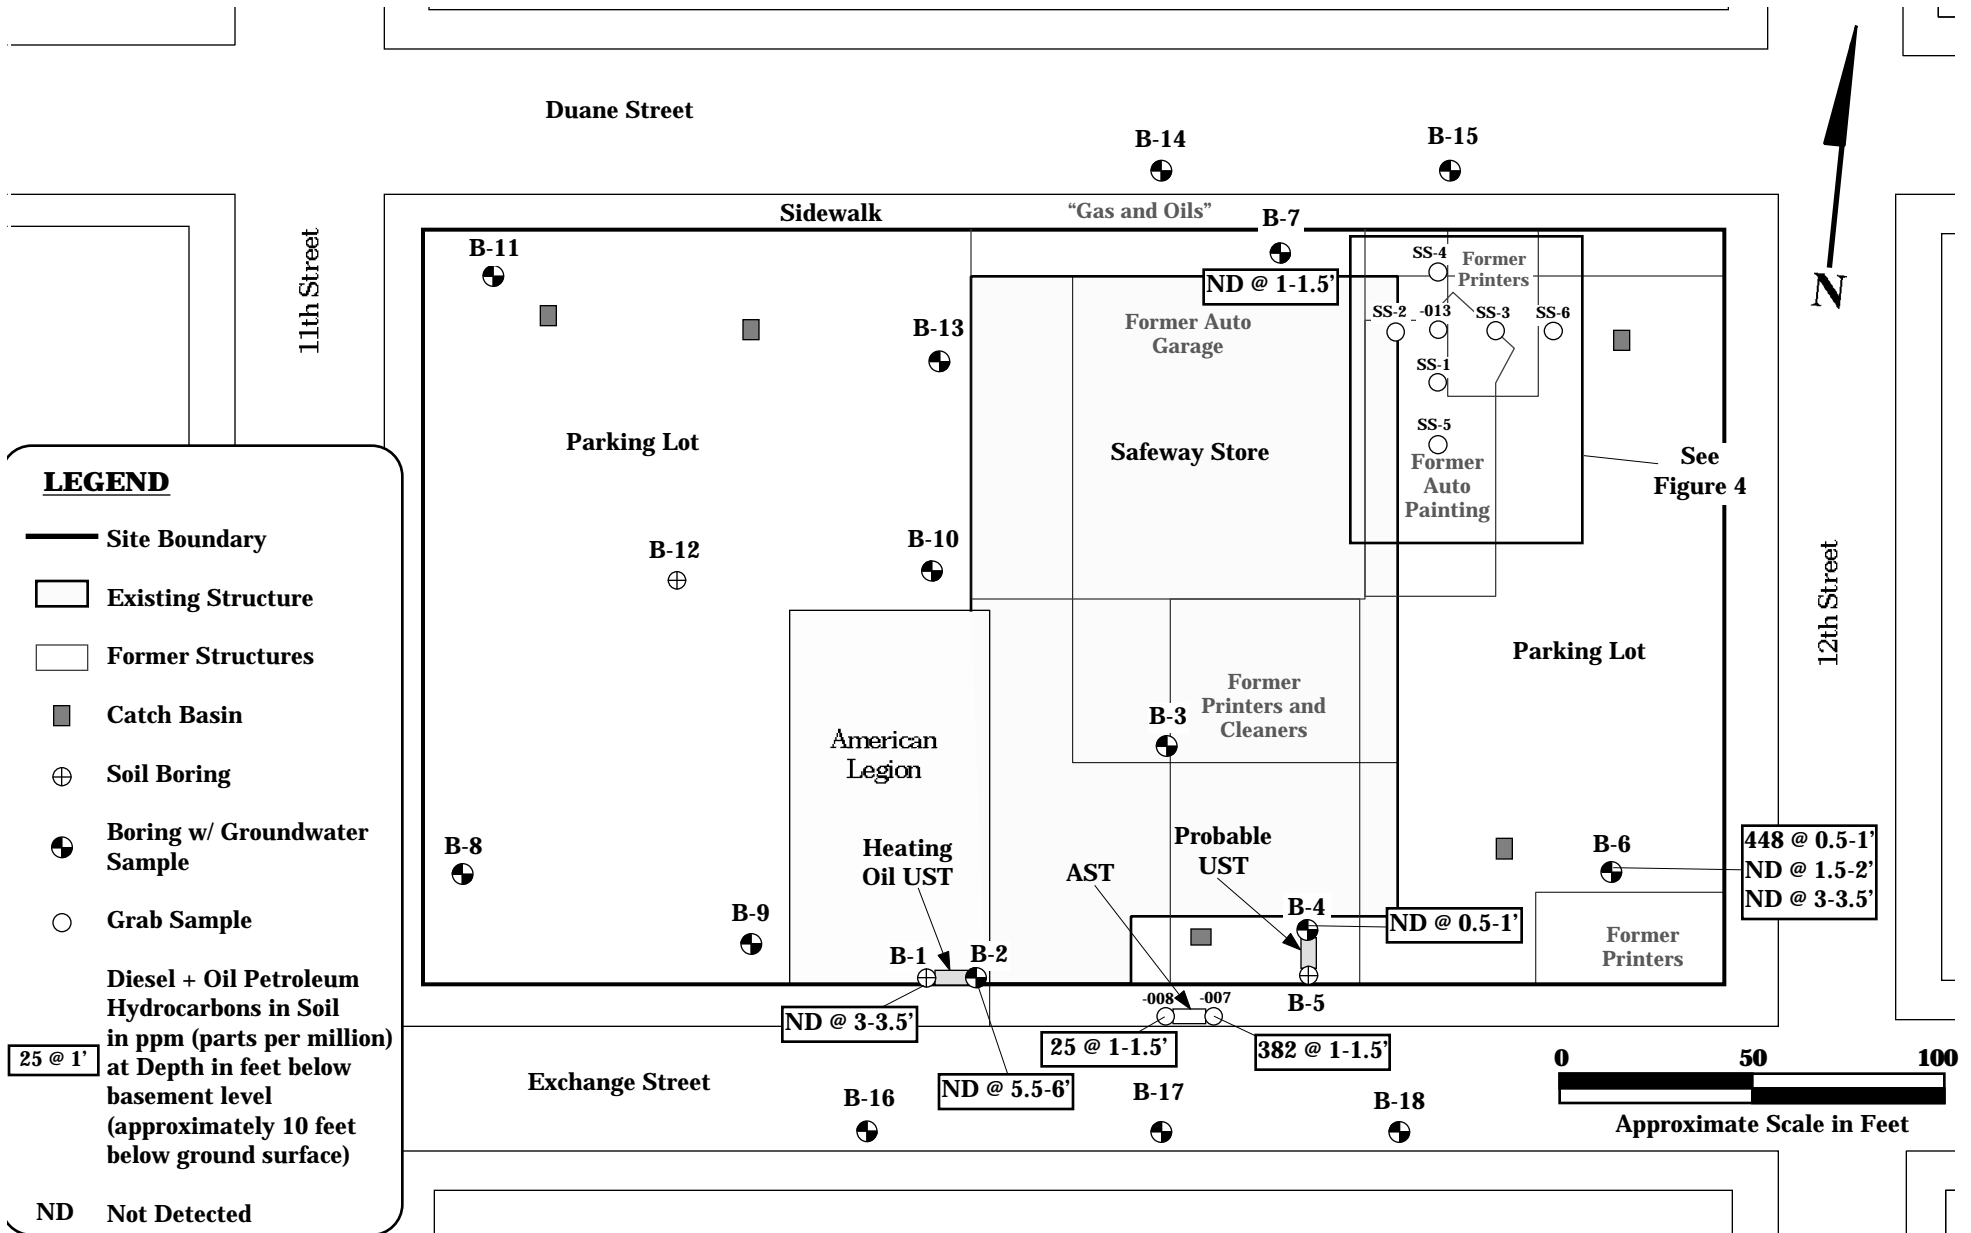
Of the 15 soil samples selected for analysis of petroleum hydrocarbons, diesel-and/or oil-range petroleum hydrocarbons were detected above method detection limits in nine soil samples (Table 2, Figure 3). The detected concentrations of diesel-range petroleum

hydrocarbons ranged from 24.5 to 2,000 parts per million (ppm), and oil-range petroleum hydrocarbons ranged from 110 to 6,390 ppm. The petroleum hydrocarbons were detected in near-surface soils at three areas of the site: 1) the Safeway AST area (25 to 382 ppm diesel and oil); 2) beneath a former printer on the southeast corner of the site at B-6 (448 ppm oil); and 3) beneath a former auto painting and former printers in the northeast portion of the site (124 to 8,390 ppm diesel and oil) (Figure 4).

The detected total concentrations of petroleum hydrocarbons in soil exceed the Oregon Department of Environmental Quality (DEQ) Level 2 Soil Matrix Cleanup Standard of 500 ppm (OAR 340-122-0335) only in the former auto painting and former printers area beneath the northeast portion of the site. The lateral extent of TPH above the Soil Matrix Cleanup Standard is not determined, and the petroleum hydrocarbon levels do not appear to display a definable pattern. Although the vertical extent of petroleum contamination is not directly defined by samples in this area, it is not expected to extend very deep because of the presence of groundwater at 2 to 3 feet below the basement level.

If left in-place, undisturbed, it does not appear any actions would be necessary with respect to the identified petroleum contaminated soils, as long as access to the unfinished basement level continues to be restricted. However, if excess soils are generated during re-development of this area, then special management of these soils may be necessary. If cleanup of the impacted soils were deemed necessary, the most feasible remedial options would appear to be removal, capping, or some combination of the two. Capping would likely be the least cost remedial option, but would require additional investigation to verify the remedy would be appropriate and protective.
